Tillamook Estuaries Partnership
A National Estuary Project

This correspondence serves as Tillamook Estuaries Partnership's (TEP) first interim effectiveness monitoring report for the Miami Wetlands Effectiveness Monitoring grant (OWEB Grant No. 211-1012-8406). It meets requirements for interim monitoring reports established in Exhibit B, Section 3(b) of our OWEB grant agreement. Specifically, this document responds to paragraphs 1-4 in Exhibit C of the original grant agreement.

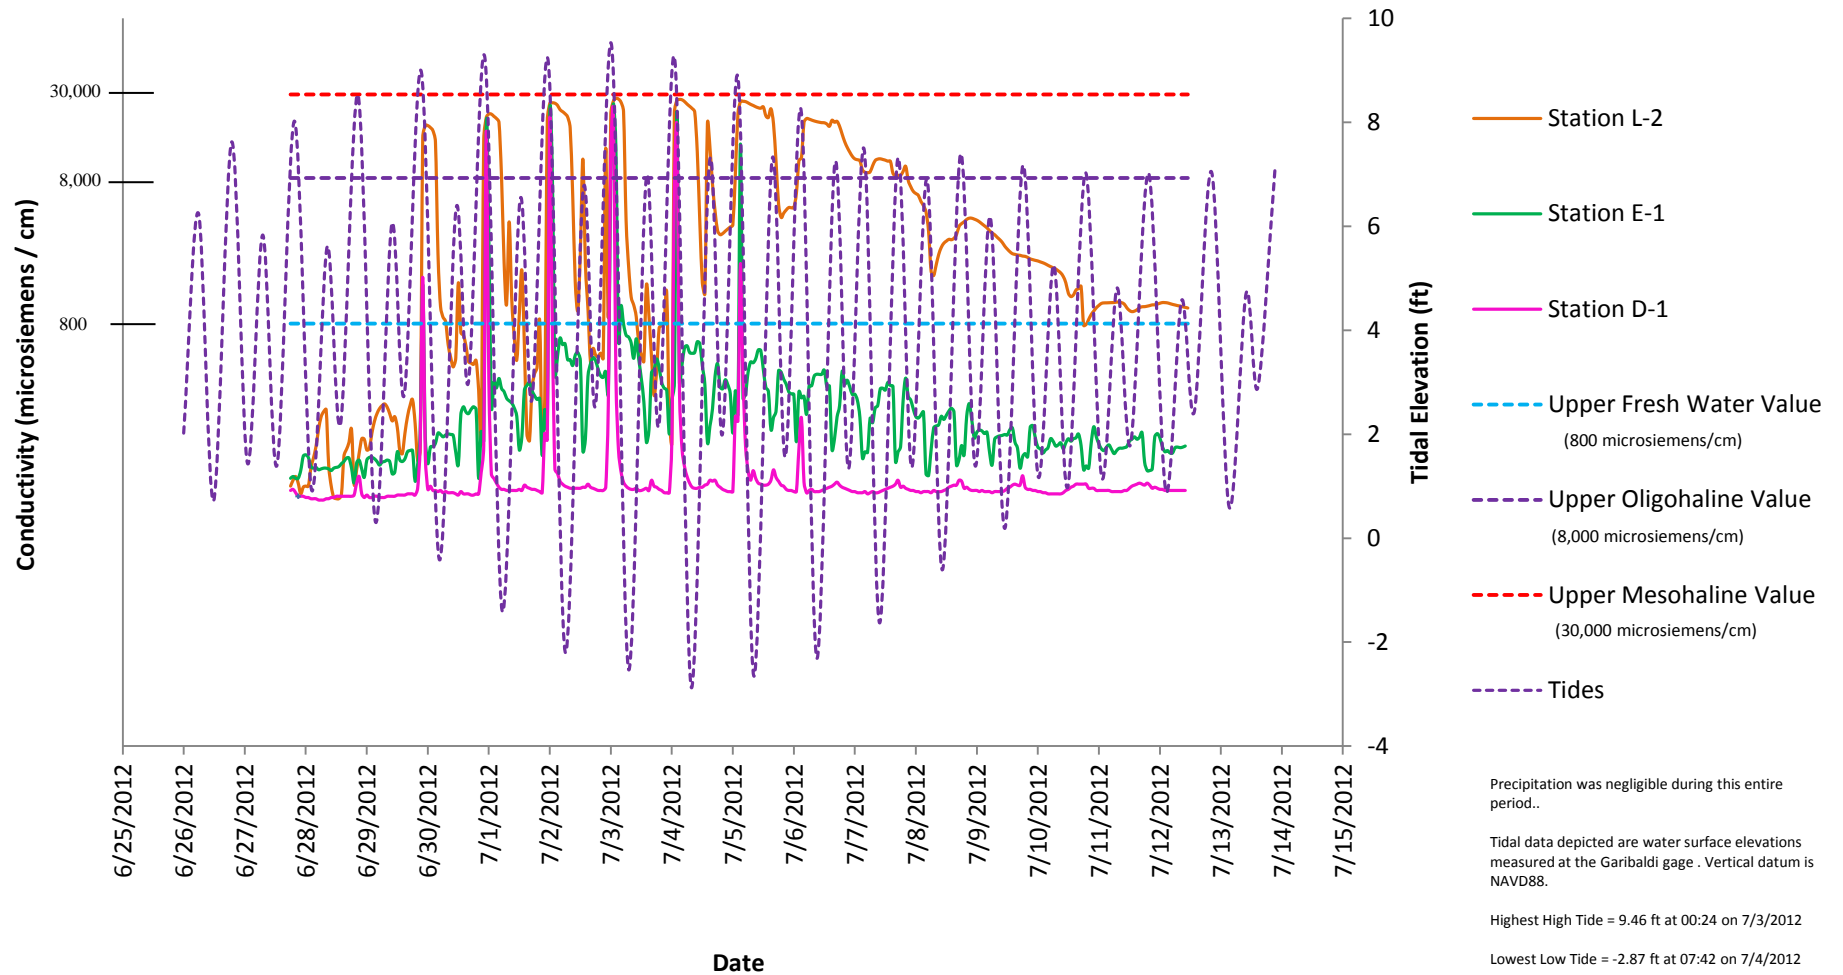
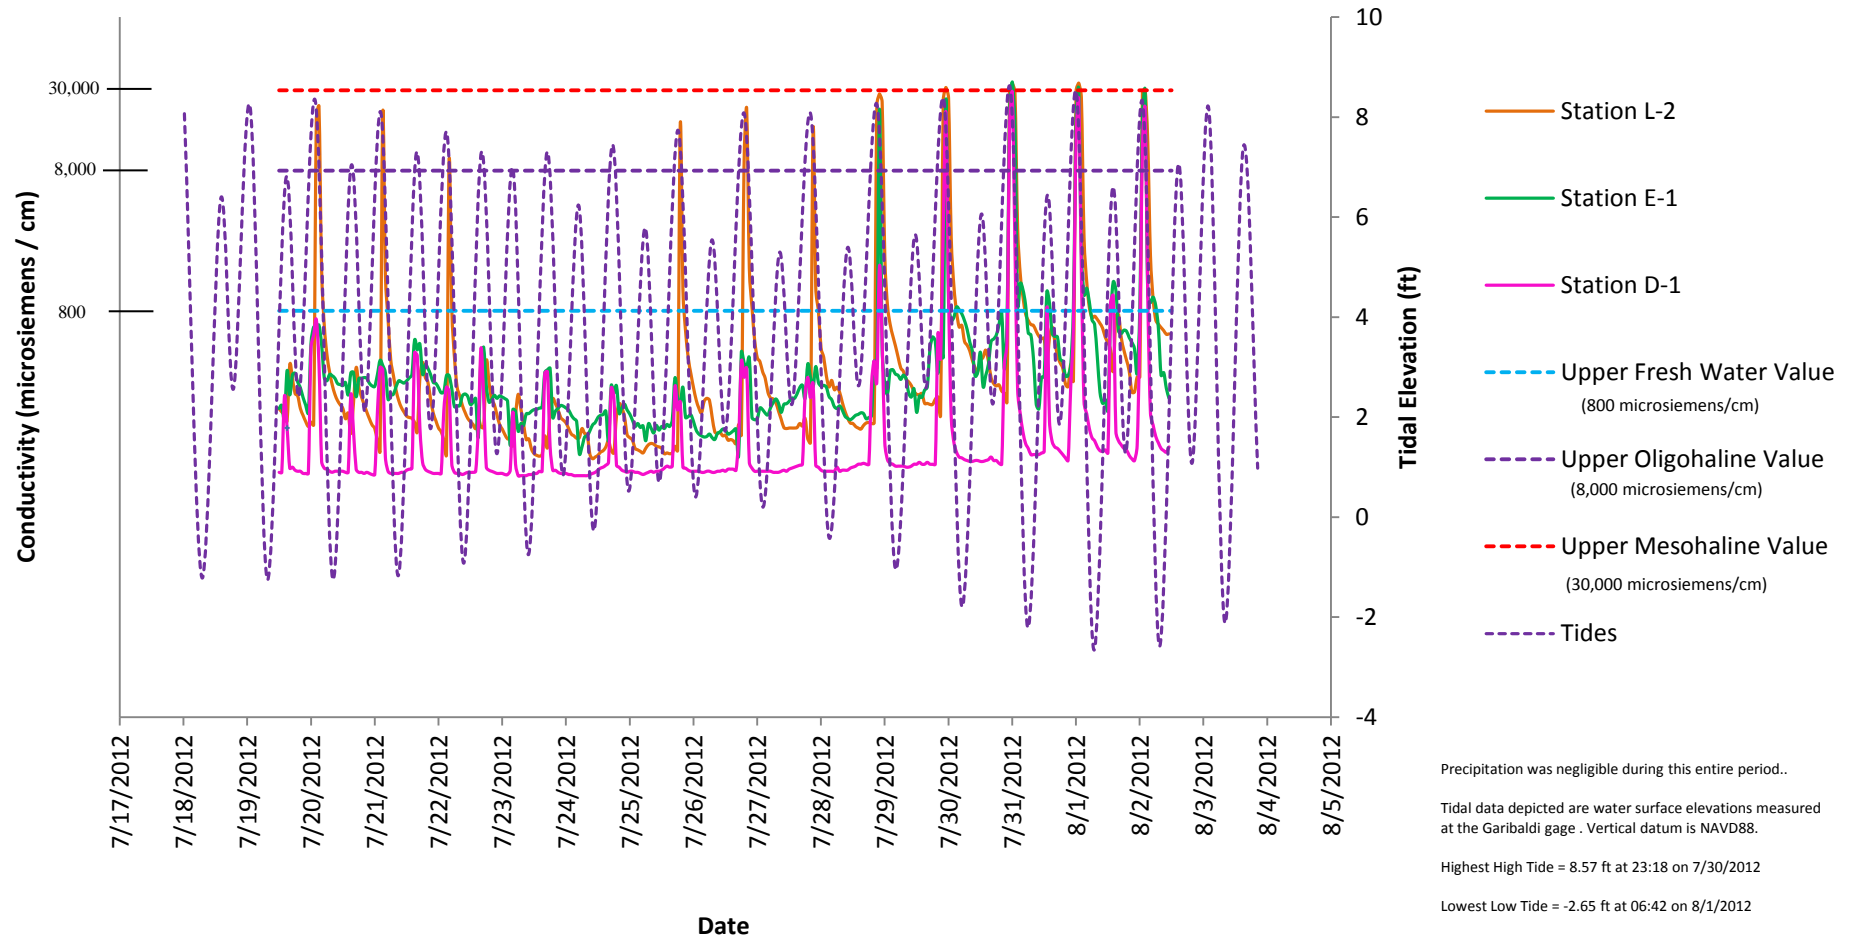
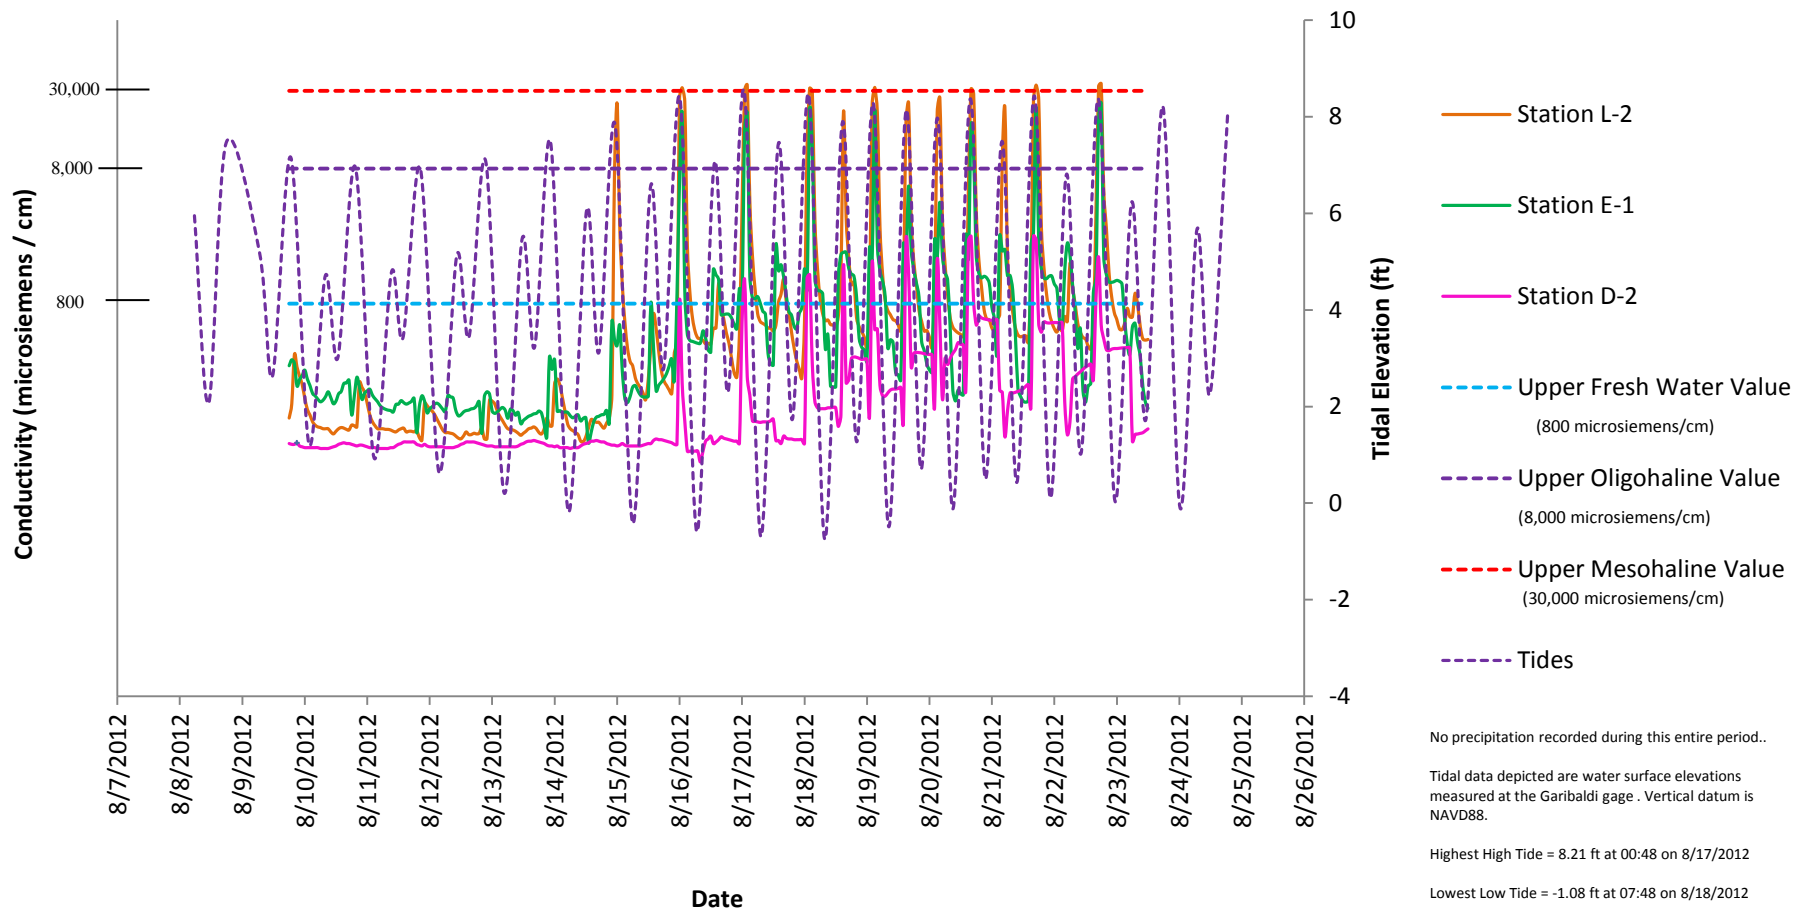
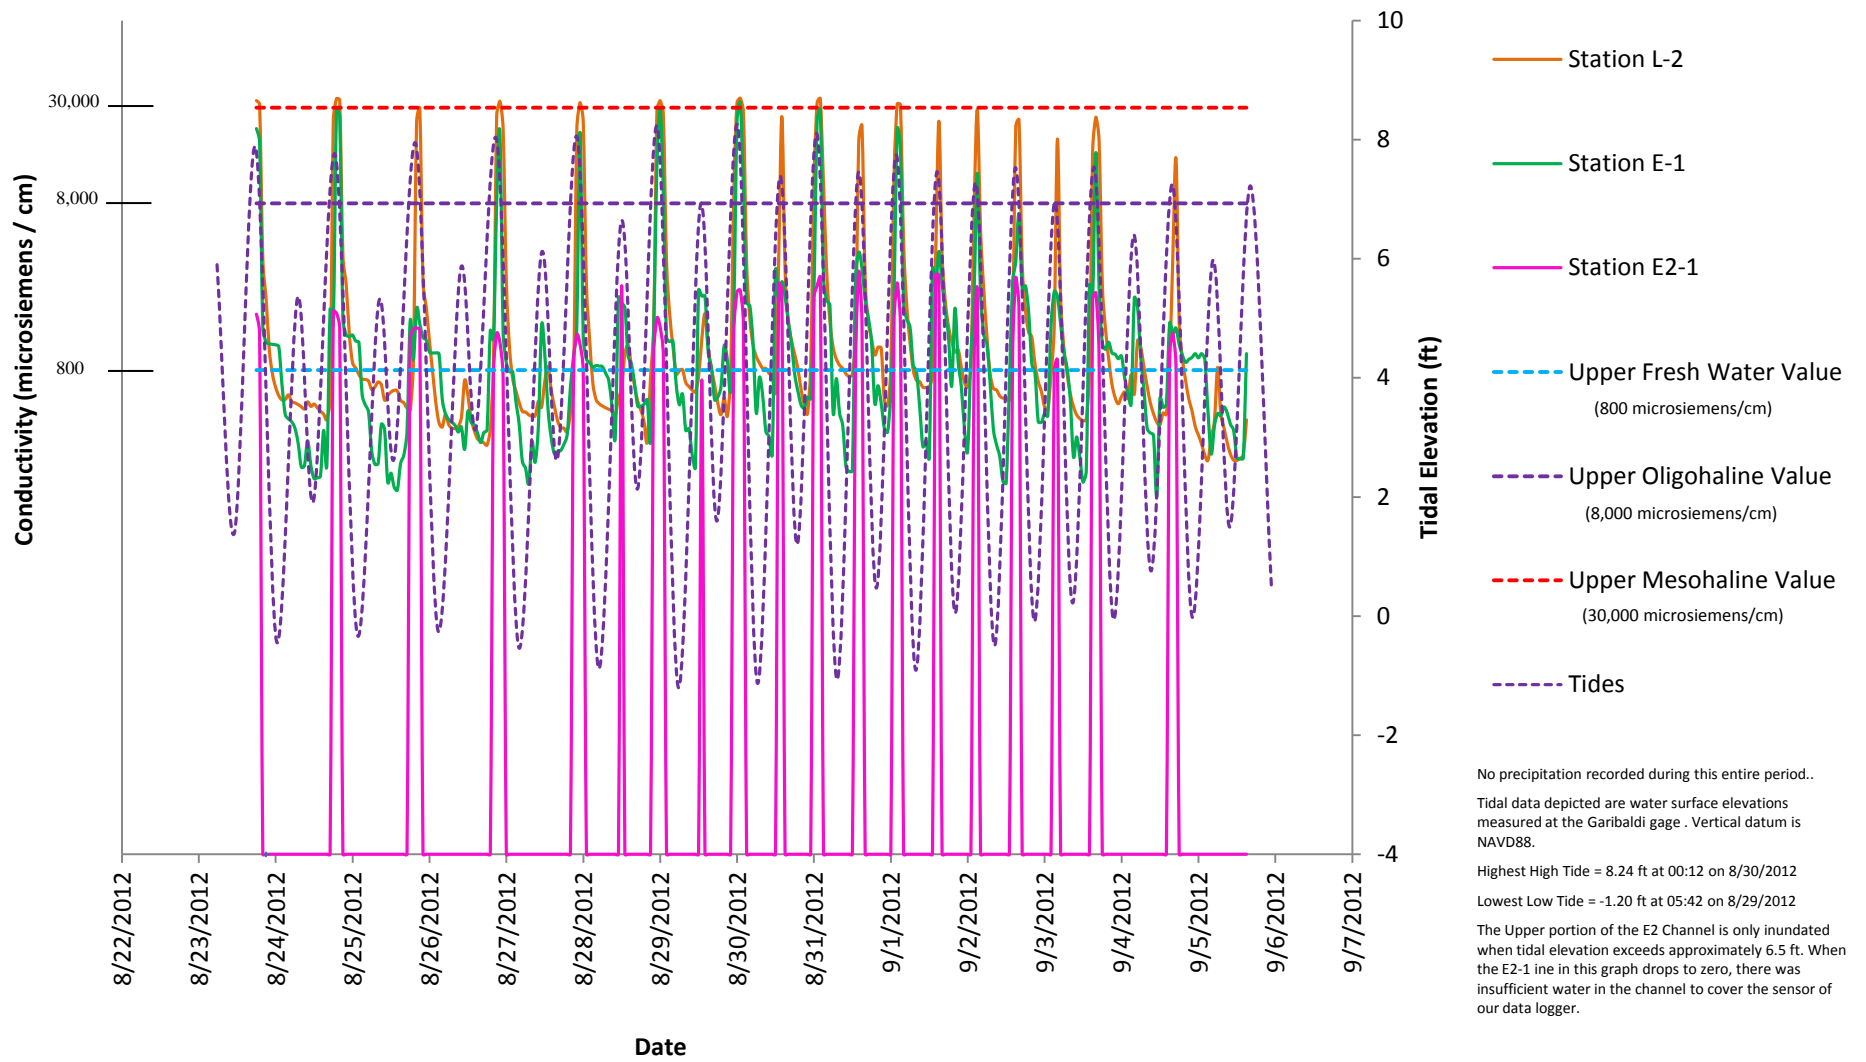
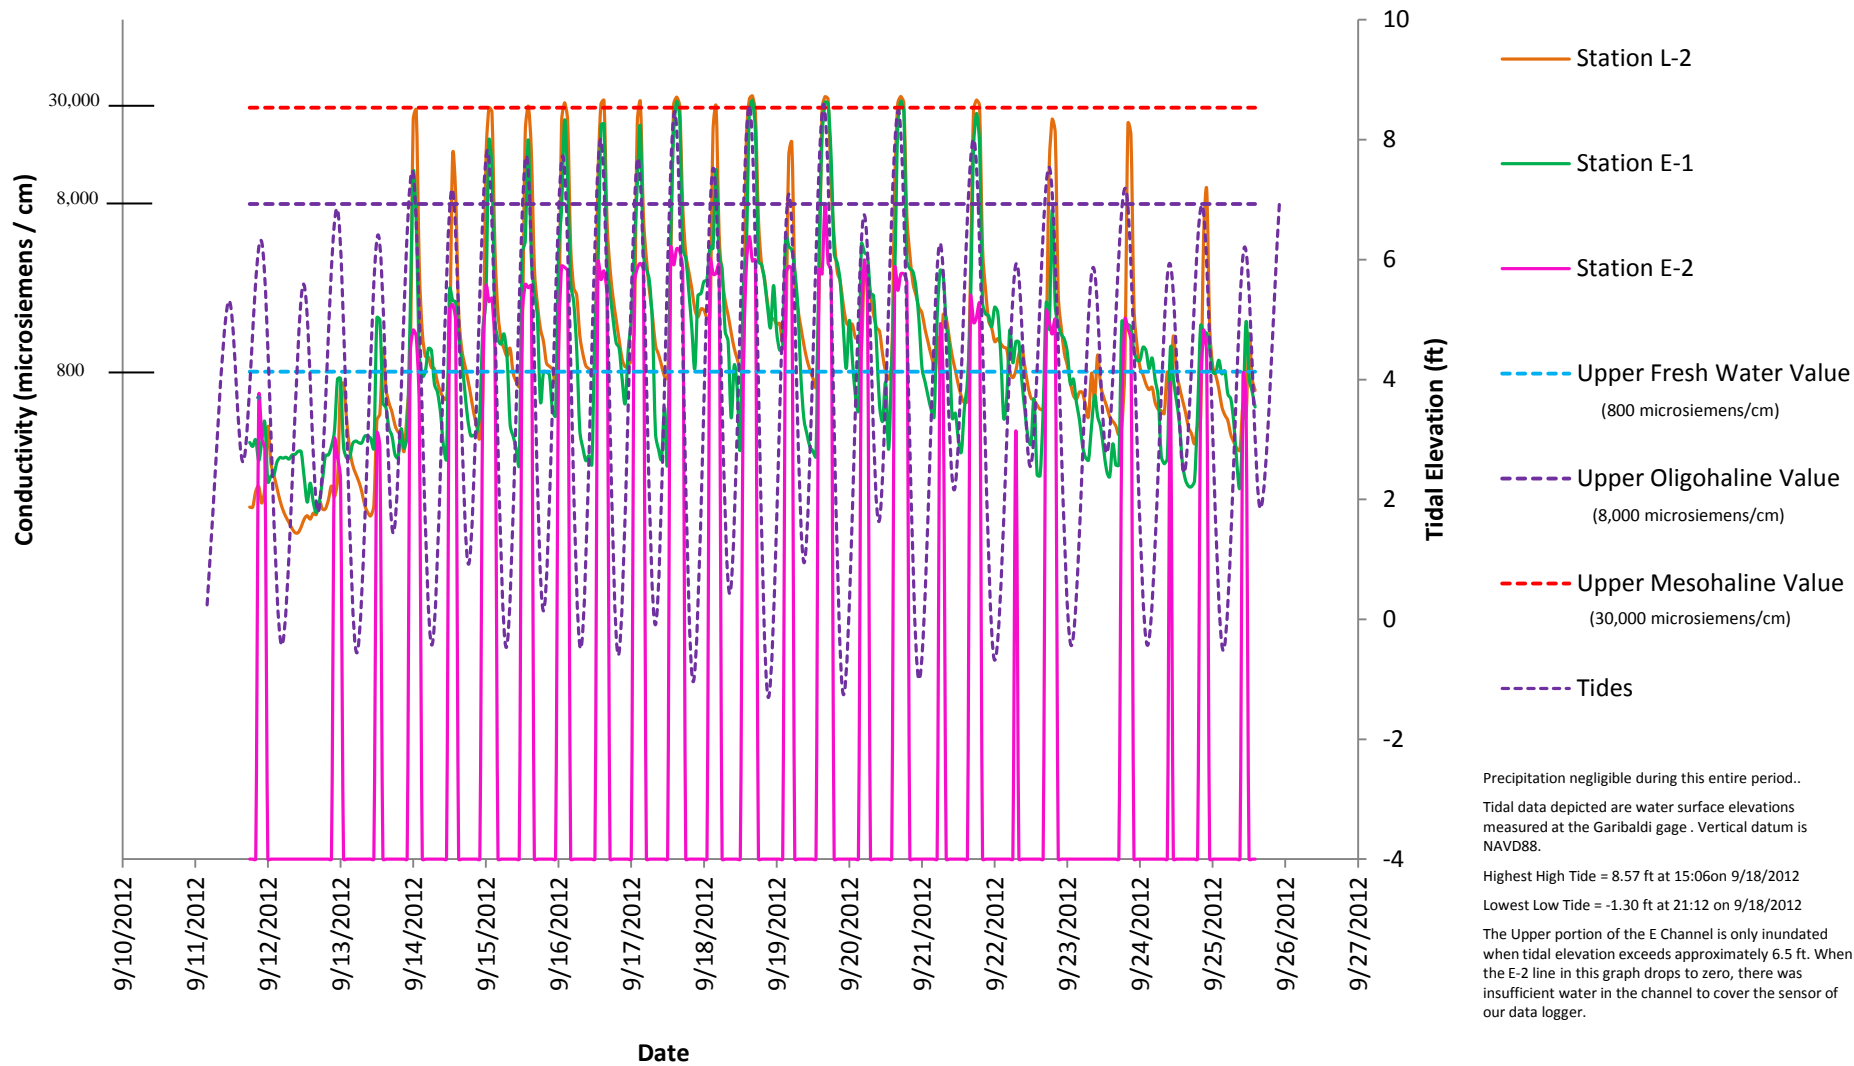
Figure 8. Graphs depicting conductivity recorded during five water quality logger deployments at the Miami Wetlands site during summer 2022. Refer to Figure 7 for station locations.
